# Unplanned Interruptions Report

for the assessment period ended 31 March 2023

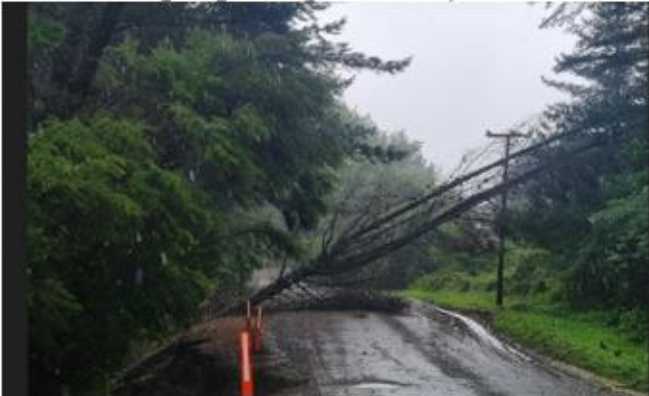
Photograph 1: line damage caused by trees outside the fall zone going through lines in April 2022

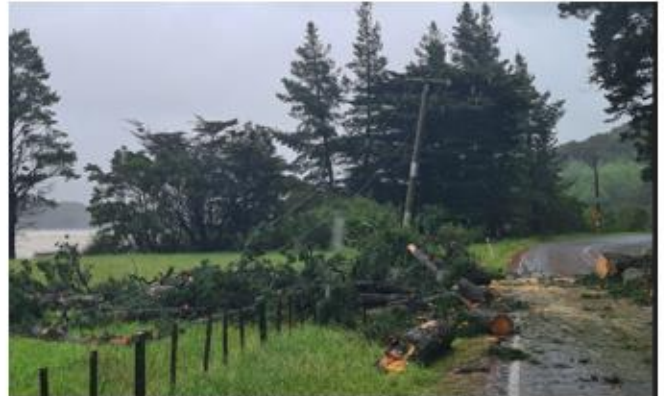
Photograph 2: line damage caused by forestry trees outside the fall zone in June 2022

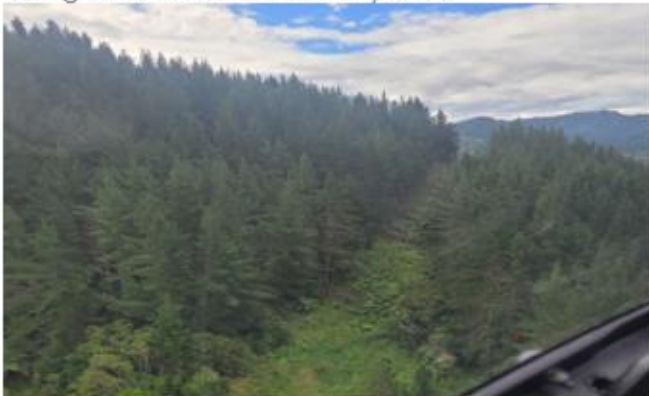
Photograph 3: lines damaged running through the Tuangaheru Mata forest in July 2022

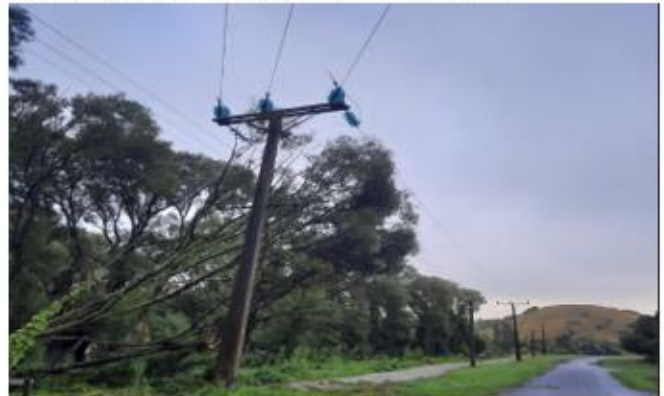
Photograph 4: Line damage in Tirioto caused by trees outside the fall zone in November 2022

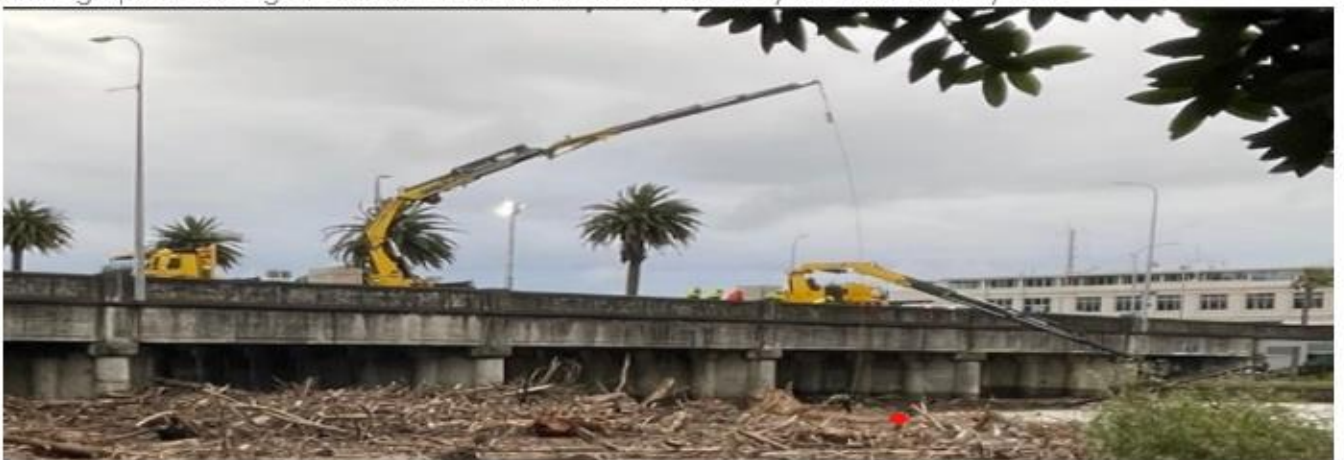
Photograph 5: damage to infrastructure in Tairāwhiti caused by floods in January 2022

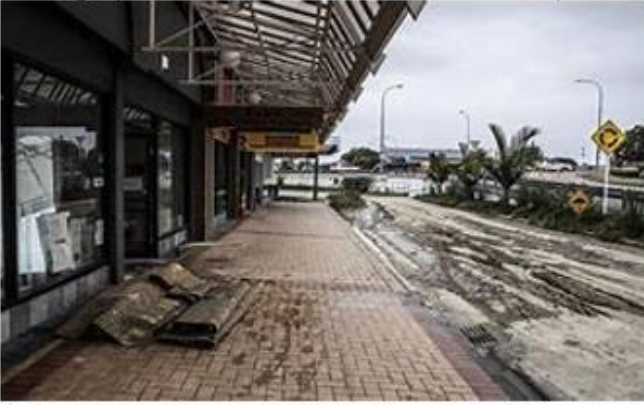
Photograph 6: Main street of Wairoa township

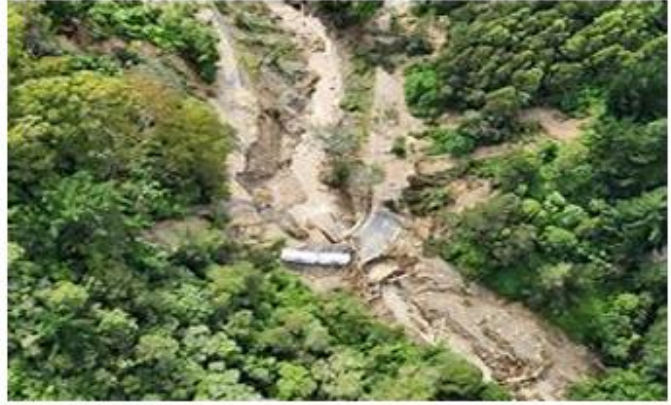
Photograph 7: Roading impacted in Tairāwhiti

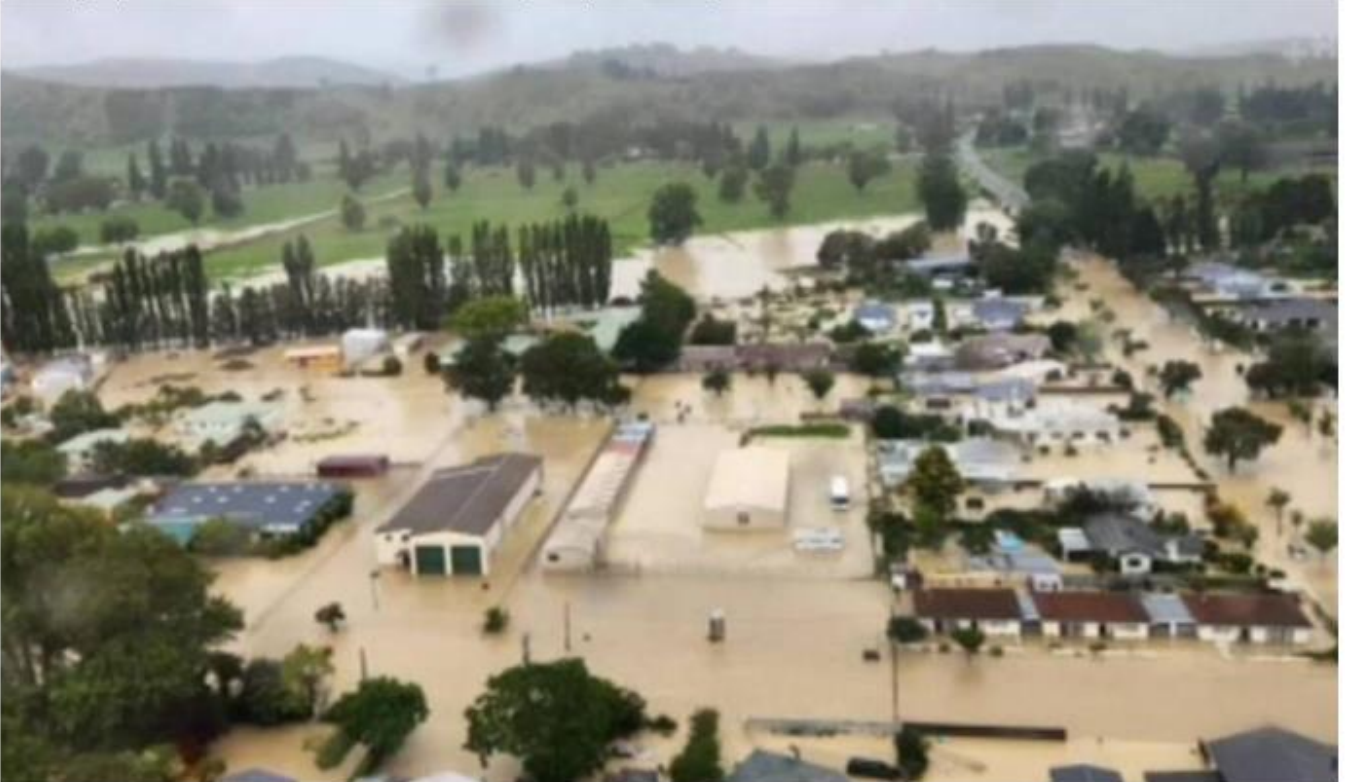
Photograph 8: The town of Wairoa is completely cut off by flood waters

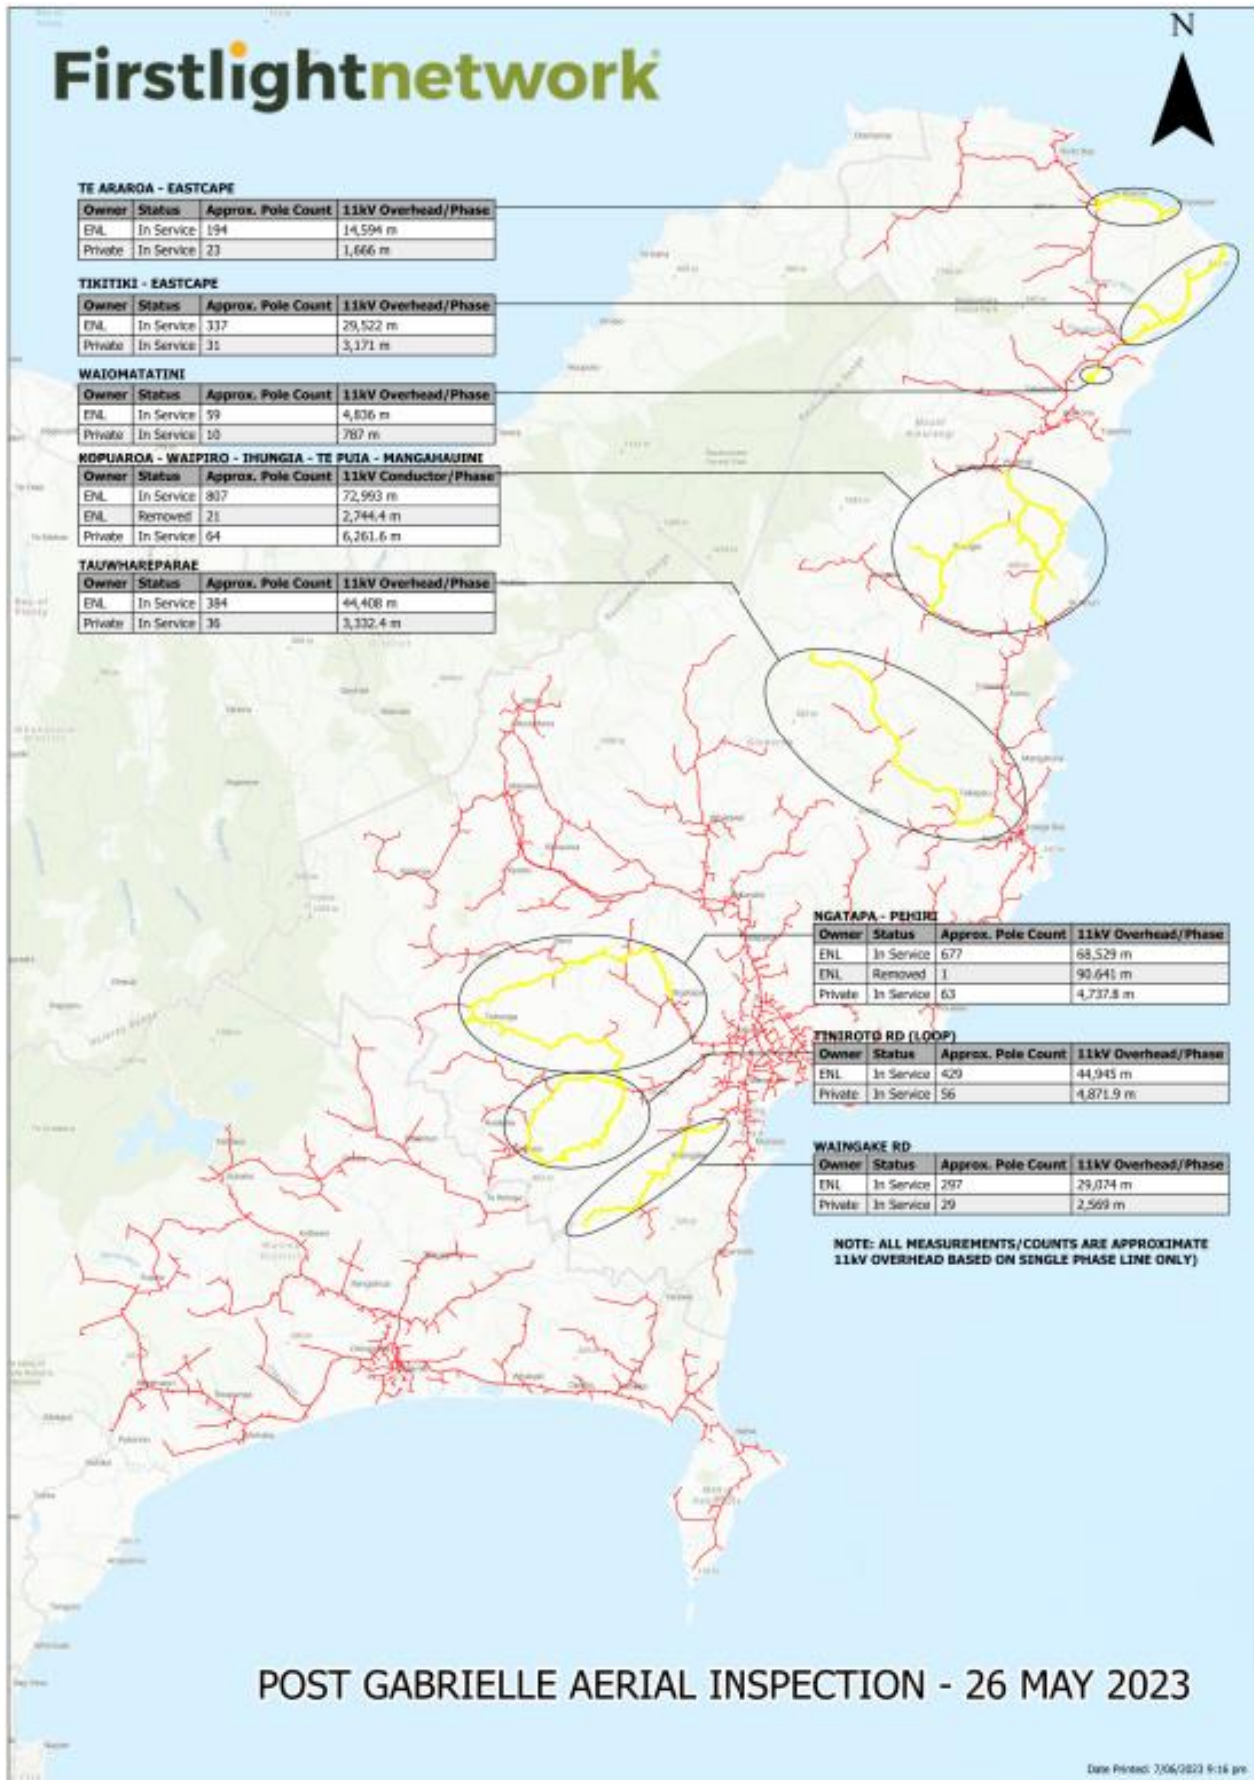
Figure 5: Post-Gabrielle Aerial Inspection

To assess the initial impacts of Cyclone Gabrielle on our network, we undertook an aerial review of the impacted areas, with a strong focus on the state of our distribution lines (results are shown in Figure 5). We inspected a sample of feeders and assessed the damage, e.g., slips near poles, leaning poles, and trees that had an increased probability of contacting our lines (i.e., trees made unstable by high winds that were at an increased risk of falling into our lines post the event).

- 2,165 poles, marked 174 for replacement and 176 for remedial maintenance, as
- 536 transformers, earth tested 564, and found 317 defects, as shown.

In the weeks following Cyclone Gabrielle, we combined the information collected via the flyover and ground observations. We updated our routine maintenance programs to reflect the state of our network post-Cyclone Gabrielle. We identified 11 issues arising from Cyclone Gabrielle that needed immediate attention, remained we rolled into our routine maintenance program. We inspected 13% of our distribution lines (i.e., 309 km of our 2,388 km 11kv conductor) and 12% of our poles (i.e., 3181 of our 25,485 11kv poles). We have included a summary of the results in Table 3.
