# Unplanned Interruptions Report

for the assessment period ended 31 March 2023

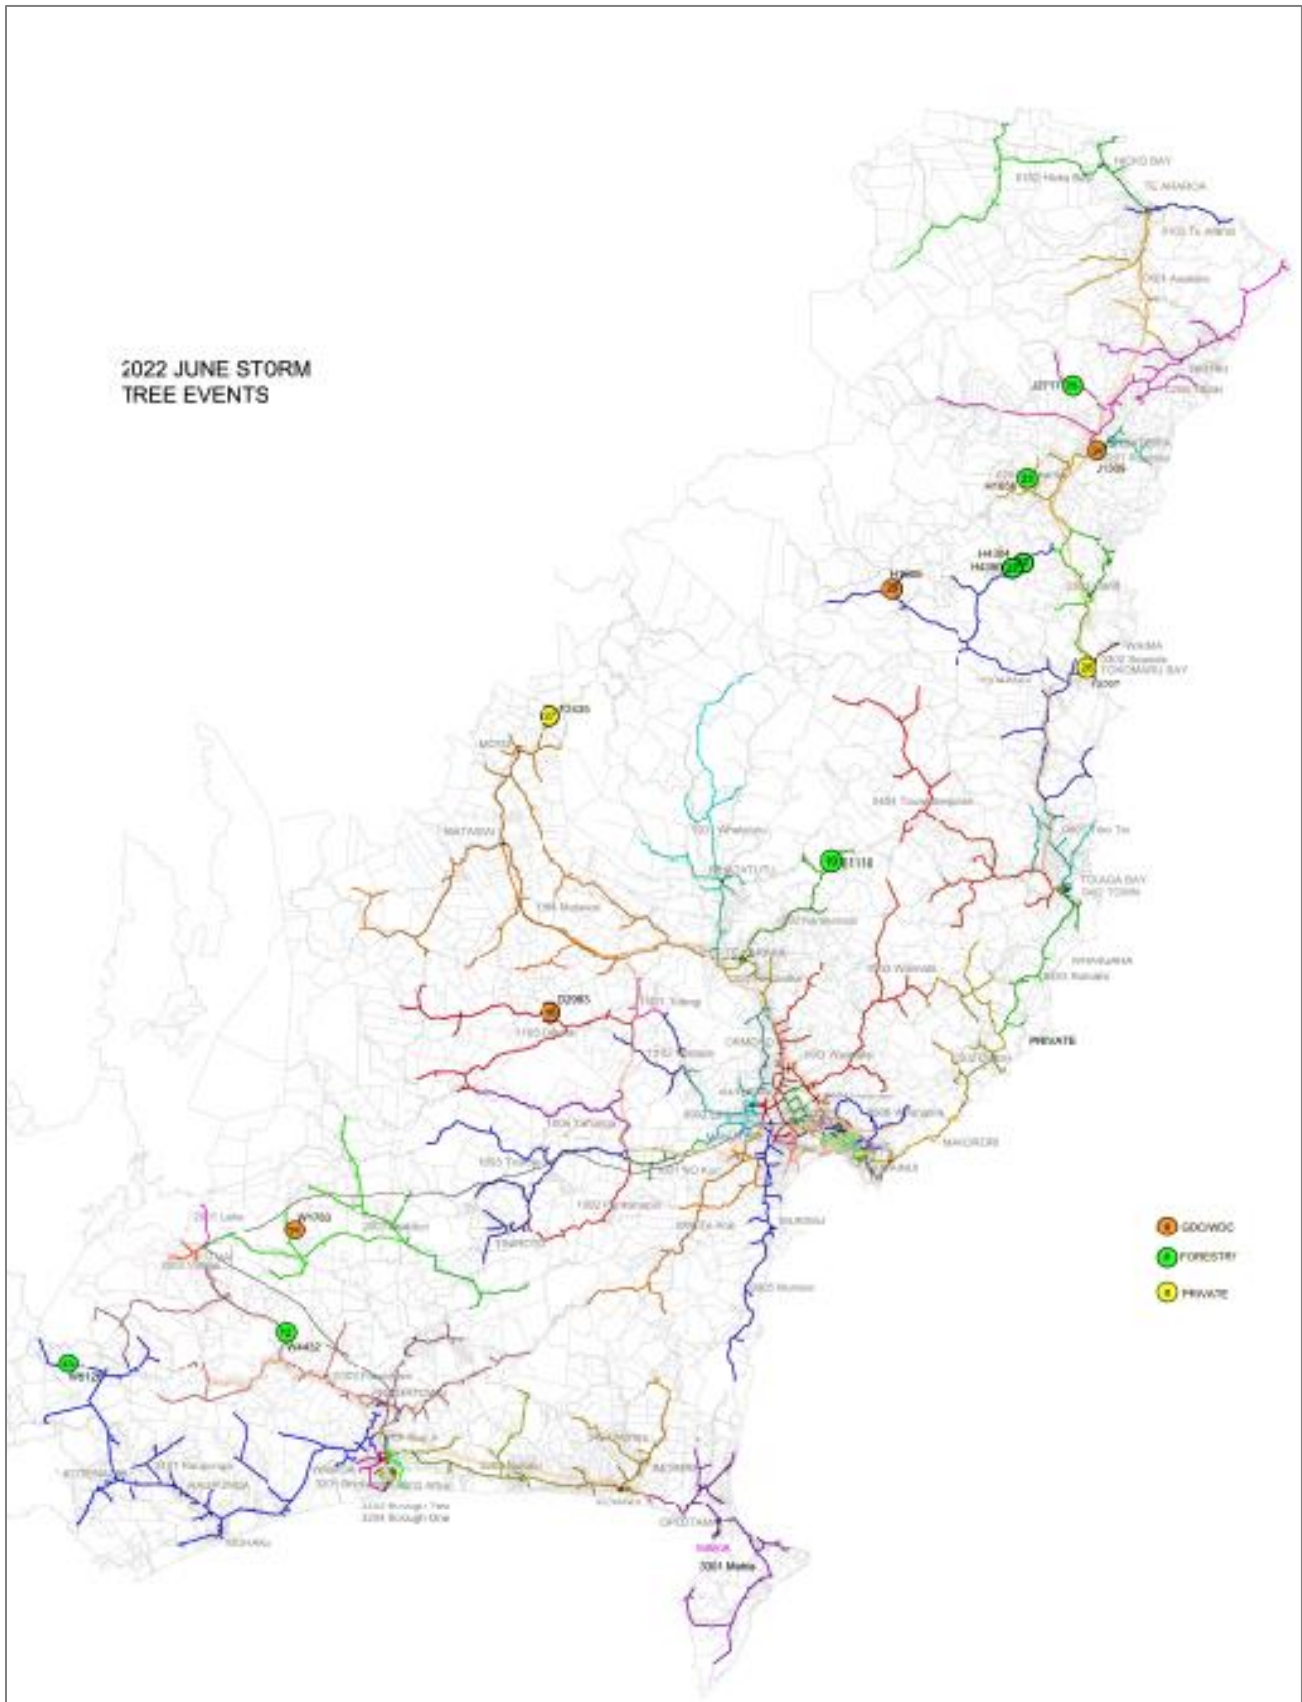
Figure 2: Tree Fault Map June 2023

Figure 2 to Figure 4 are maps of the damage to our network caused by trees in June, July, and January. The maps illustrate that tree damage during the period was sporadic and widespread. Vegetation management and tree ownership do not appear to contribute to tree damage. The maps show a mix of council, forestry, and privately owned trees caused damage to the network. Our records show that the areas were part of our vegetation management programme, and the trees causing the damage were outside the regulated notice and growth limit zone.

Damage to our lines during the assessment year was not from trees within the notice or growth limit zone. Rather the extreme weather conditions resulted in out-of-zone trees being thrown into our lines, causing extensive damage. The regulations give us no power to manage vegetation outside the notice zone, leaving us vulnerable to outages caused by out-of-zone trees.

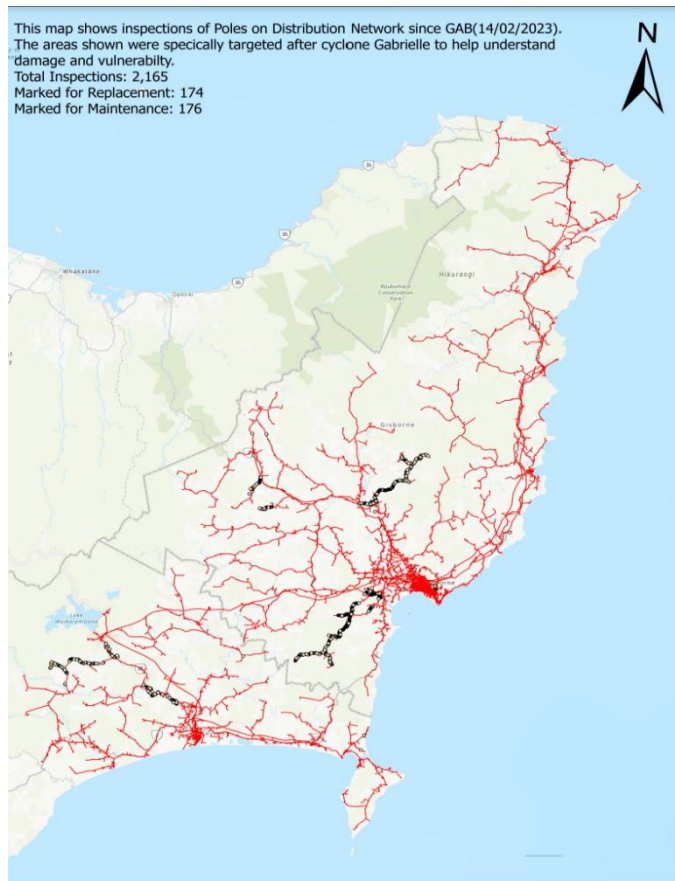
- 2,165 poles, marked 174 for replacement and 176 for remedial maintenance, as
- 536 transformers, earth tested 564, and found 317 defects, as shown.

The maps in Figure 6 and Figure 12 show the worst areas impacted by Cyclone Gabrielle and reveal the scale of the impact on our Network.

Figure 6: Map showing pole inspections arising from ariel review following Cyclone Gabrielle

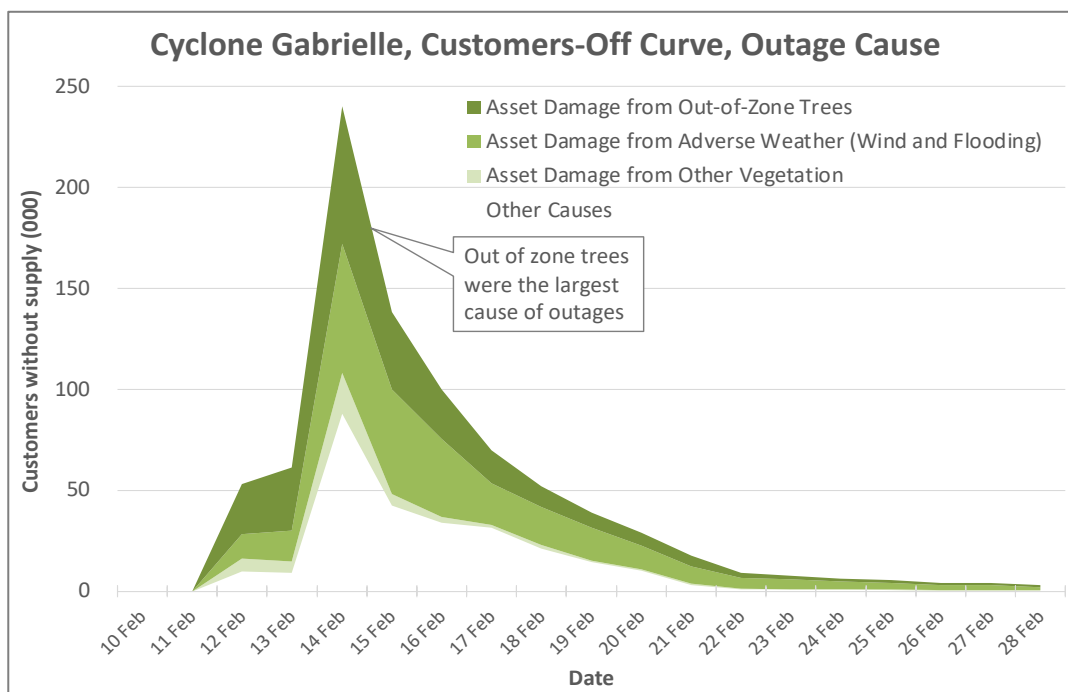
Energia determined that the largest cause of outages for EDBs was out-of-zone tree damage, and the second largest cause was high winds causing damage to overhead lines, followed by flooding damaging assets (including substations), as shown in Figure 8.<sup>13</sup>

Figure 8: Material causes of customer outages extract from the energia report<sup>14</sup>

Trees pose a significant hazard to distribution assets; strong winds increase this risk by toppling trees and breaking branches. The Tree Regulations are intended to give EDBs mandated powers to address the risk from trees. However, as discussed in Sub-section 2.2.2 above, EDBs are not mandated to trim or remove trees outside the growth zone (i.e., out-of-zone trees). EDBs must negotiate with the tree owner to trim or remove trees at risk of damaging assets.

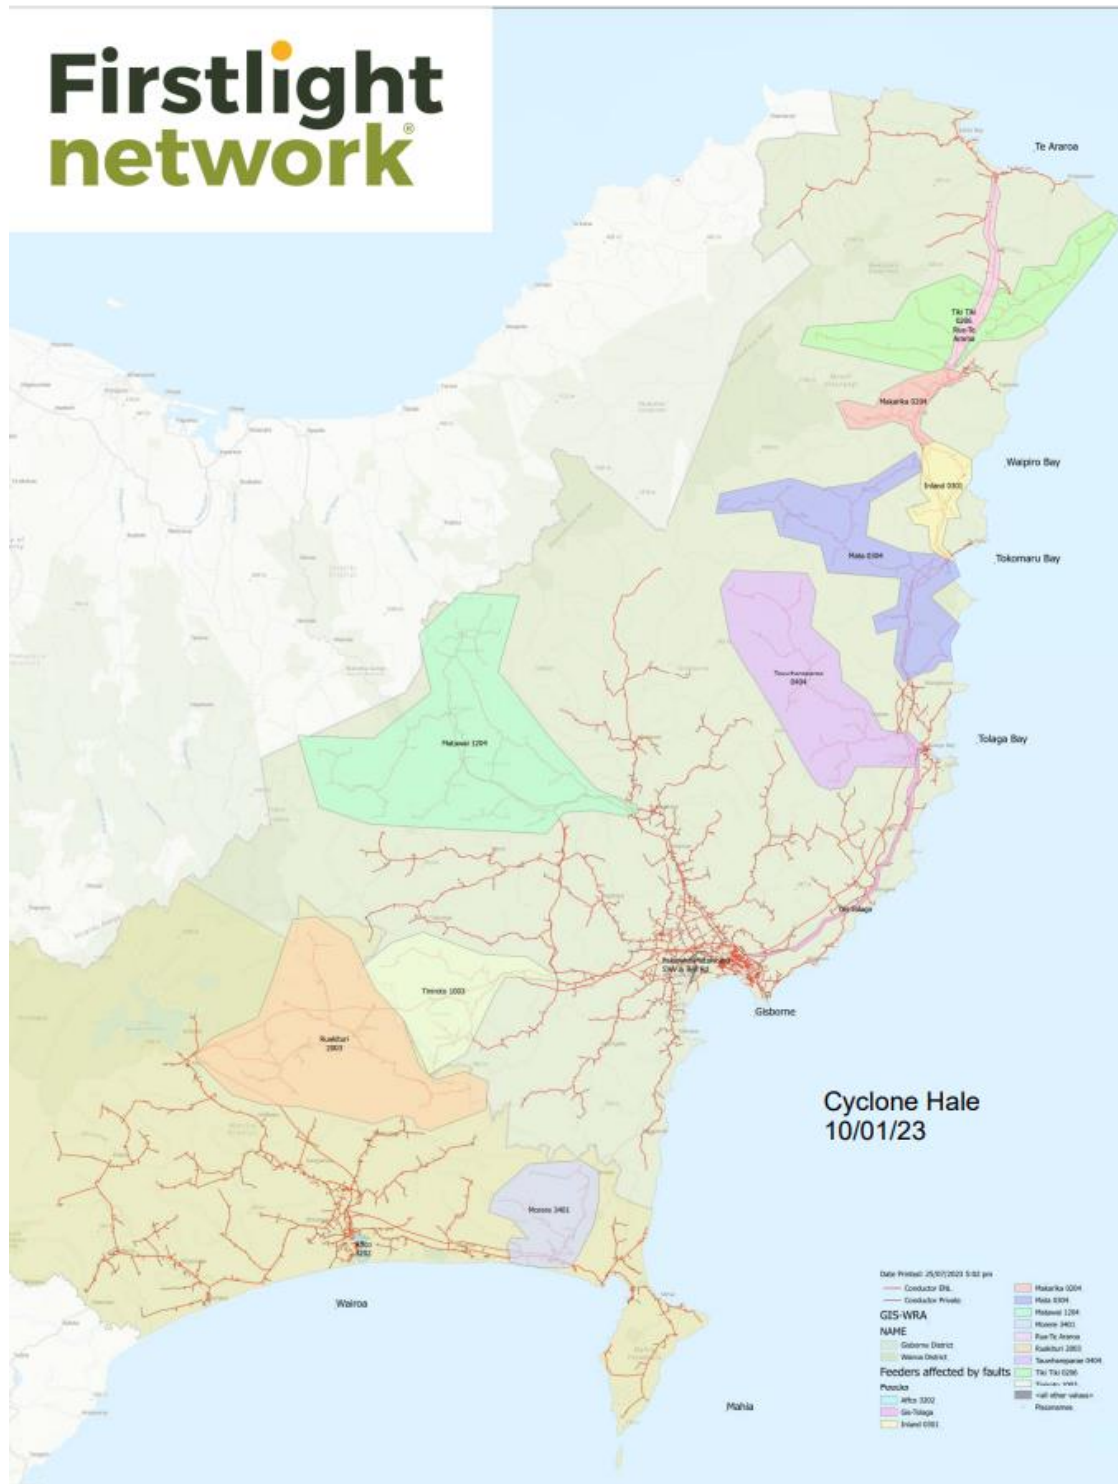
On 10 January 2023, Cyclone Hale crossed the New Zealand coasts and hit the North Island, causing widespread outages on our network and resulting in two major events. Figure 10 shows the ten regional locations of the outages that started on 10 January 2023 attributable to Cyclone Hale.

Figure 10: Firstlight Network Outage map showing the areas of our network impacted by Cyclone Hale

The brunt of the storm hit our network in the late afternoon and early evening. For health and safety, we chose not to dispatch teams to conduct a risk assessment of the lines until after the winds had died down, after 8 pm. Initial patrolling found that most faults had been caused by trees coming in contact with our lines. Most of the trees were outside the growth zone limit, with some coming from two or three rows back in plantations.

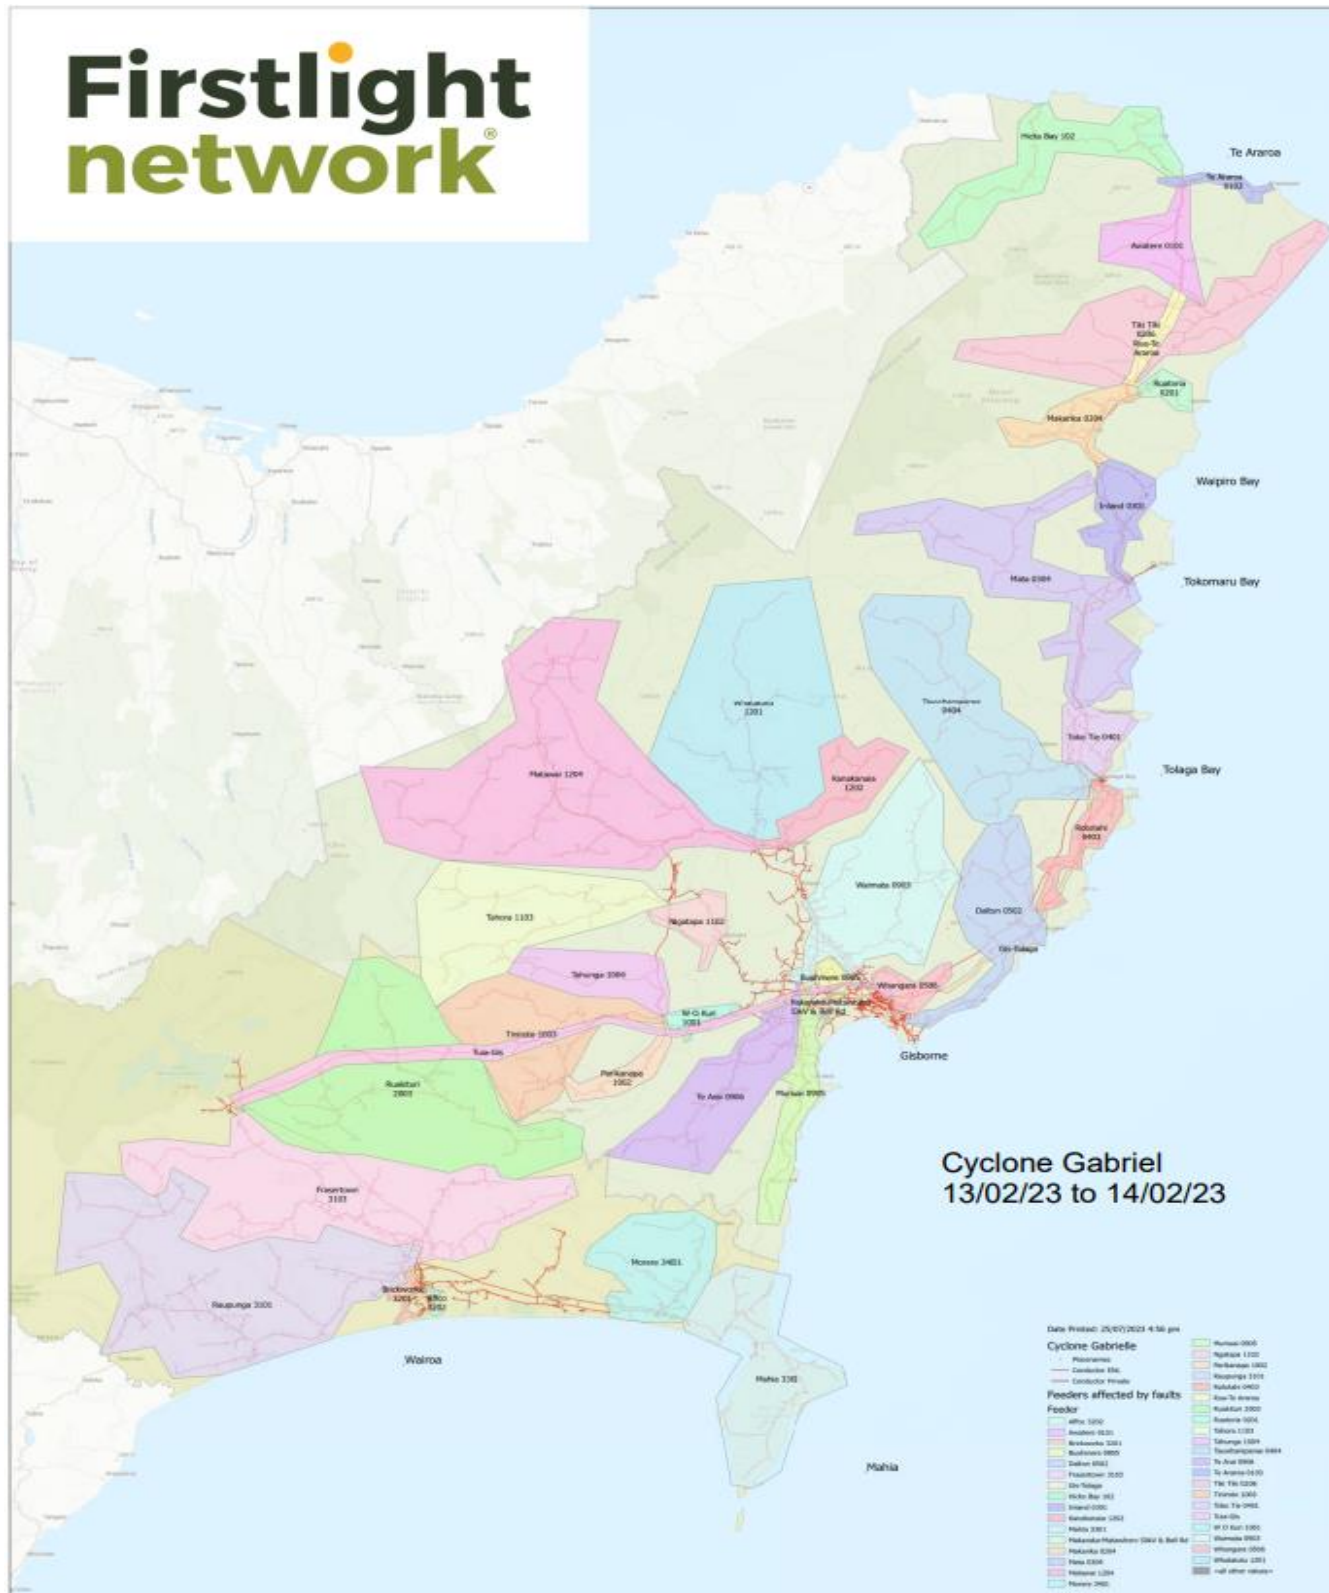
On 13 February 2023, Cyclone Gabrielle crossed the New Zealand coast and slammed into the North Island, causing widespread outages across our network from Hicks Bay in the North to Mahia in the South, as shown in Figure 11: Firstlight Network Outage map showing the areas of greatest impact from Cyclone Gabrielle and resulting in four major events.

Figure 11: Firstlight Network Outage map showing the areas of greatest impact from Cyclone Gabrielle

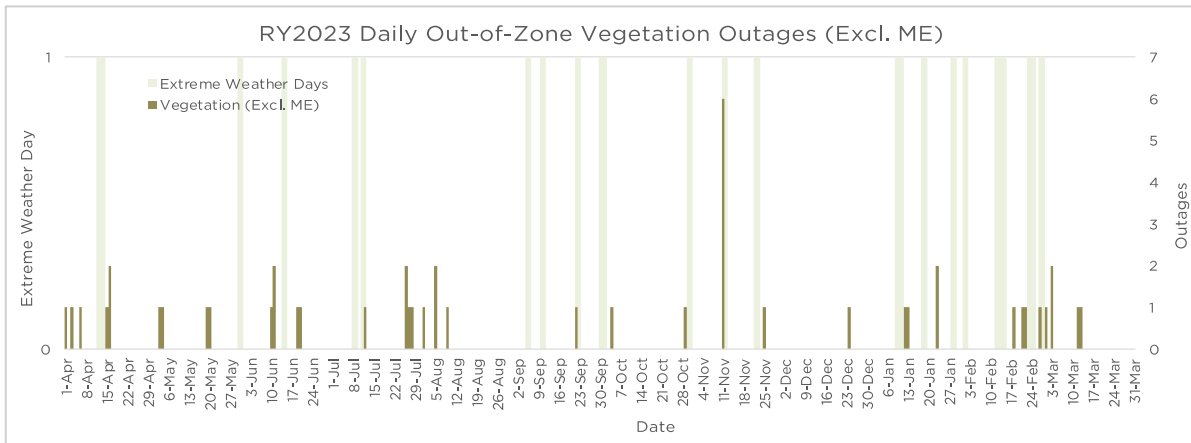
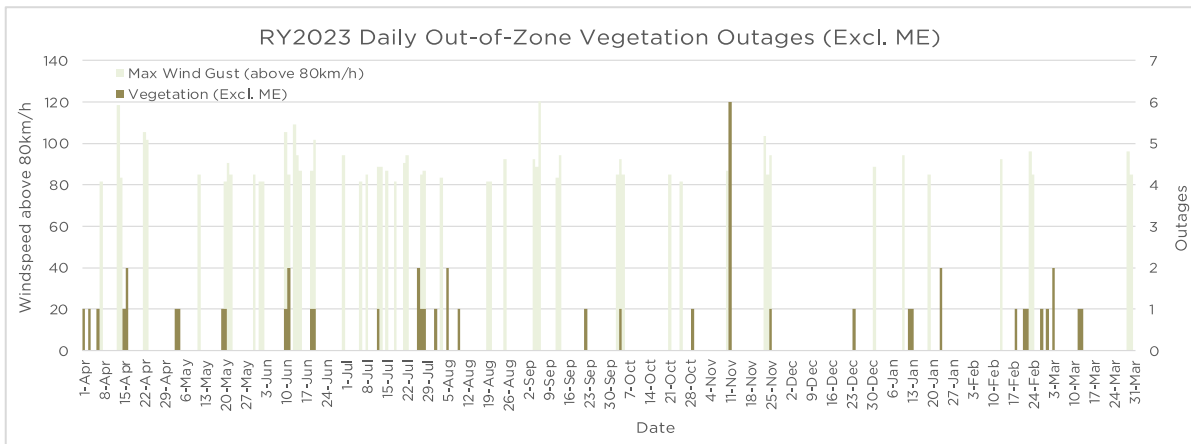
The increase in out-of-zone tree contacts was weather related. As shown in Figure 18 and Figure 19, many out-of-zone tree contacts also correlated with the high rainfall and wind.<sup>38</sup>

Figure 18: Out-of-zone tree contacts vs. Extreme Weather Days<sup>39</sup>

Figure 19: Out-of-zone tree contacts vs. high winds<sup>40</sup>

As shown in Figure 18 and Figure 19 above, we believe the weather conditions throughout the year were a key reason for the increase in out-of-zone tree outages. We consider the weather conditions abnormal and have normalised them in our counterfactual assessment.

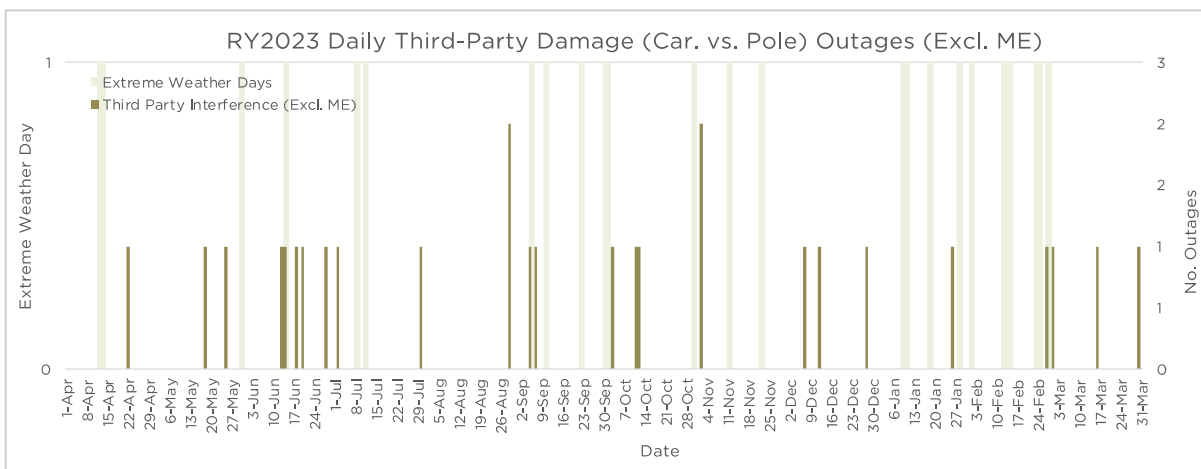
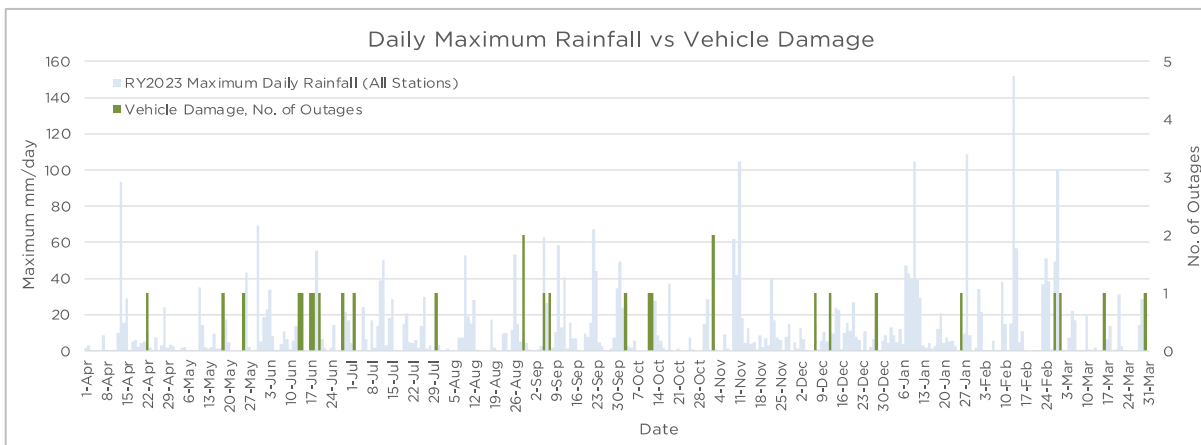
Figure 20: Vehicle Damage vs. Extreme Weather Days<sup>46</sup>

Figure 21: Vehicle Damage vs. Daily Rainfall<sup>47</sup>

As shown in Figure 20 above, we saw many vehicle damage incidents during extreme weather

events. As shown in Figure 21 above, many vehicle incidents coincided with high rainfall and wind.

As shown in Figure 20 and Figure 21 above, we believe the weather conditions throughout the year contributed to increased vehicle damage SAIDI. We consider the weather conditions abnormal and have normalised them in our counterfactual assessment.

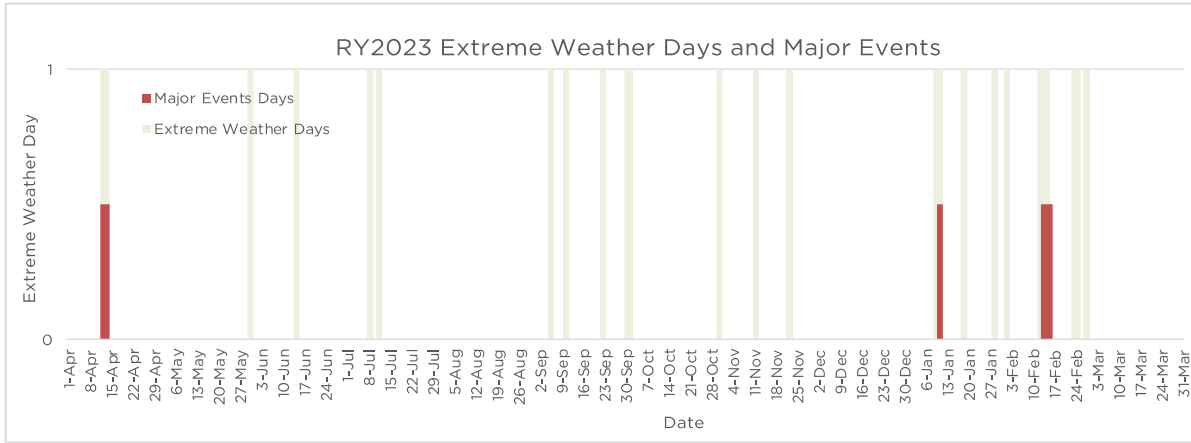
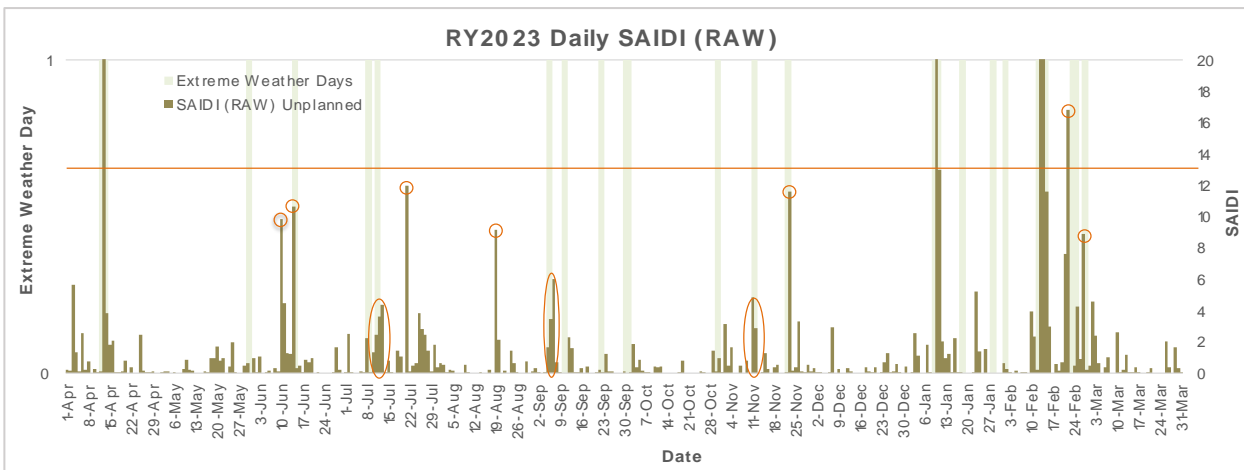
RAW SAIDI was 1,465 minutes per customer, a 263% increase over RY22 (where we experienced several extreme weather events). However, the number of rolling 24-hour periods where the Major Event trigger was met was lower than in RY22. As shown in Figure 22, there were relatively few Major Events despite many Extreme Weather Days.

The clustering of outages did not trigger many Major Events, resulting in higher assessed Unplanned SAIDI. However, as indicated in Figure 23 and Figure 24, there were many days

where significant SAIDI was incurred, with many of these being around Extreme Weather Days. There were nine 24-hour periods where the Unplanned SAIDI Major Event trigger was met (compared to 11 days experienced in the 2022 assessment period.) Four of the 24-hour Major Event periods occurred during Cyclone Gabrielle (which accounted for only four extreme weather days), meaning there were only five 24-hour Major Event periods across the remaining 40 extreme weather days. This is far lower than expected due to how the outages were clustered.

Figure 22: Major Events vs. Extreme Weather Days<sup>50</sup>

Figure 23: Raw Daily SAIDI vs. Extreme Weather Days<sup>51</sup>
